NEW MEXICO ENVIRONMENT DEPARTMENT

Re: Major Municipal; SIC 4952; Compliance Evaluation Inspection; CRRUA Sunland Park Wastewater Treatment Plant; NPDES Permit No. NM0029483; September 29, 2016

NPDES Compliance Inspection Report

Introduction

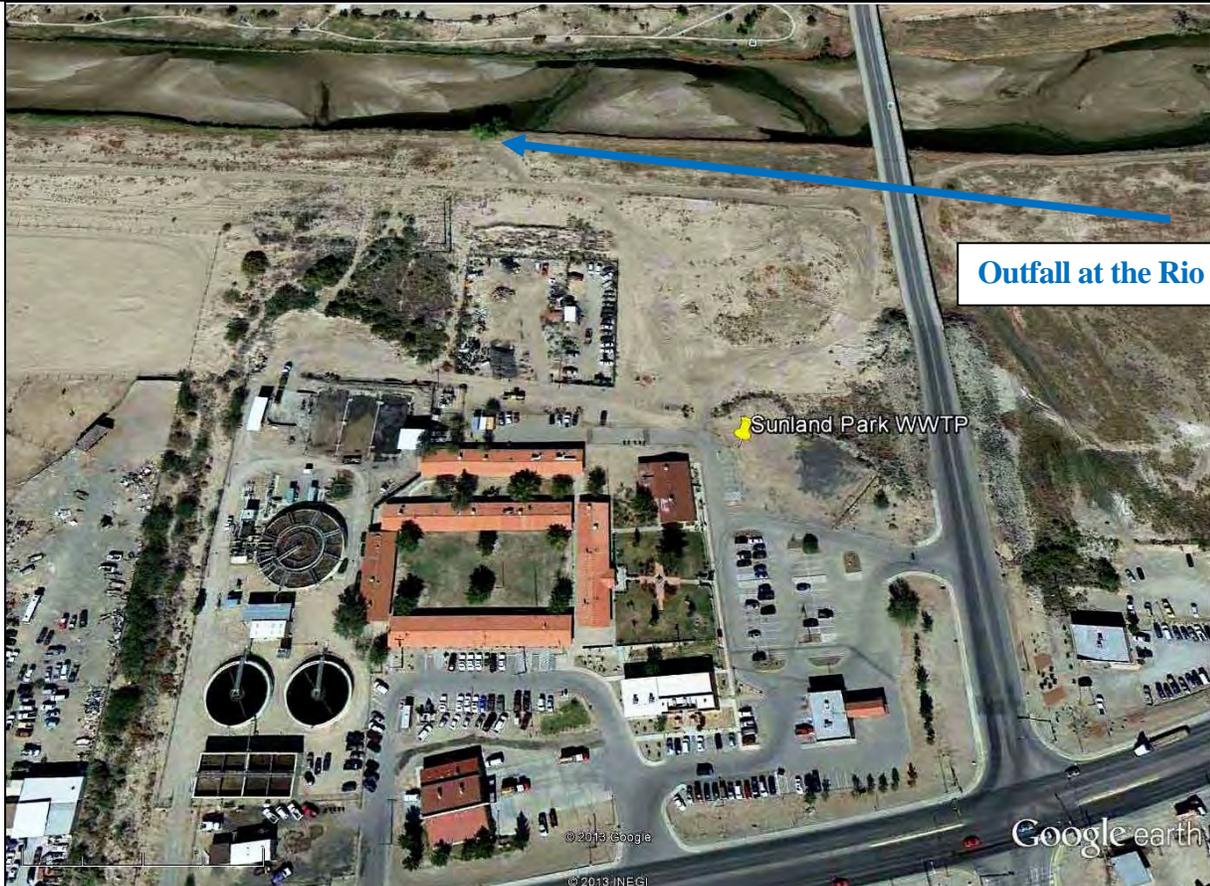
NMED/SWQB
Official Photograph Log
Photo # 1

Subject: Aerial View of the facility.

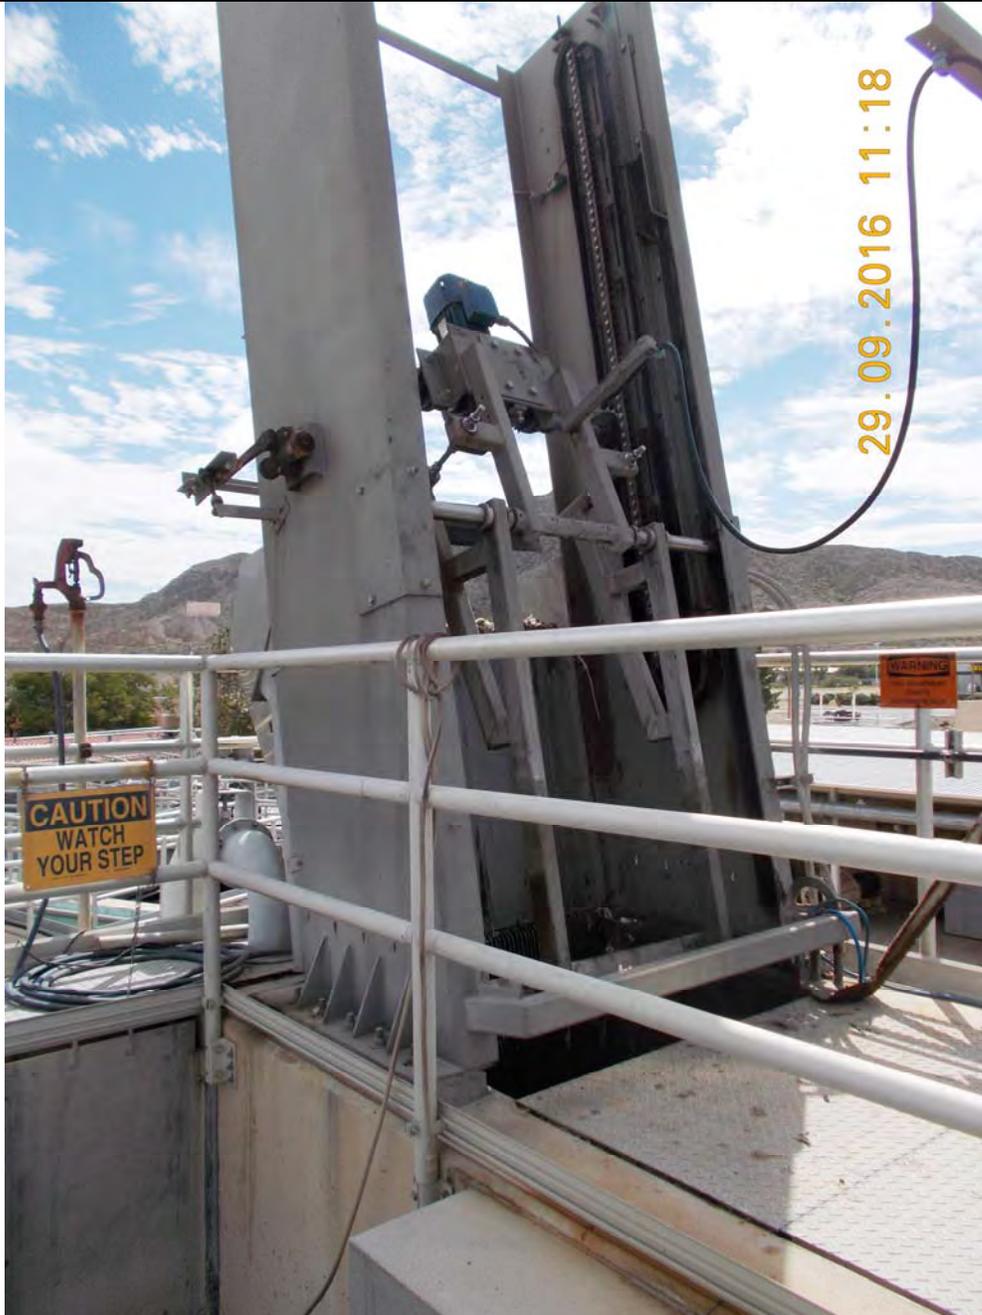
NMED/SWQB
Official Photograph Log
Photo # 2

1. Repairs and replacements have been made in the last year to the following units: the headworks bar screen & grit removal system; solids wasting, belt press and disposal; Ultra violet disinfection system and over all housekeeping at the facility. There are improvements from previous inspections.

Subject: Influent Bar Screen is operational This is an improvement from previous inspections.

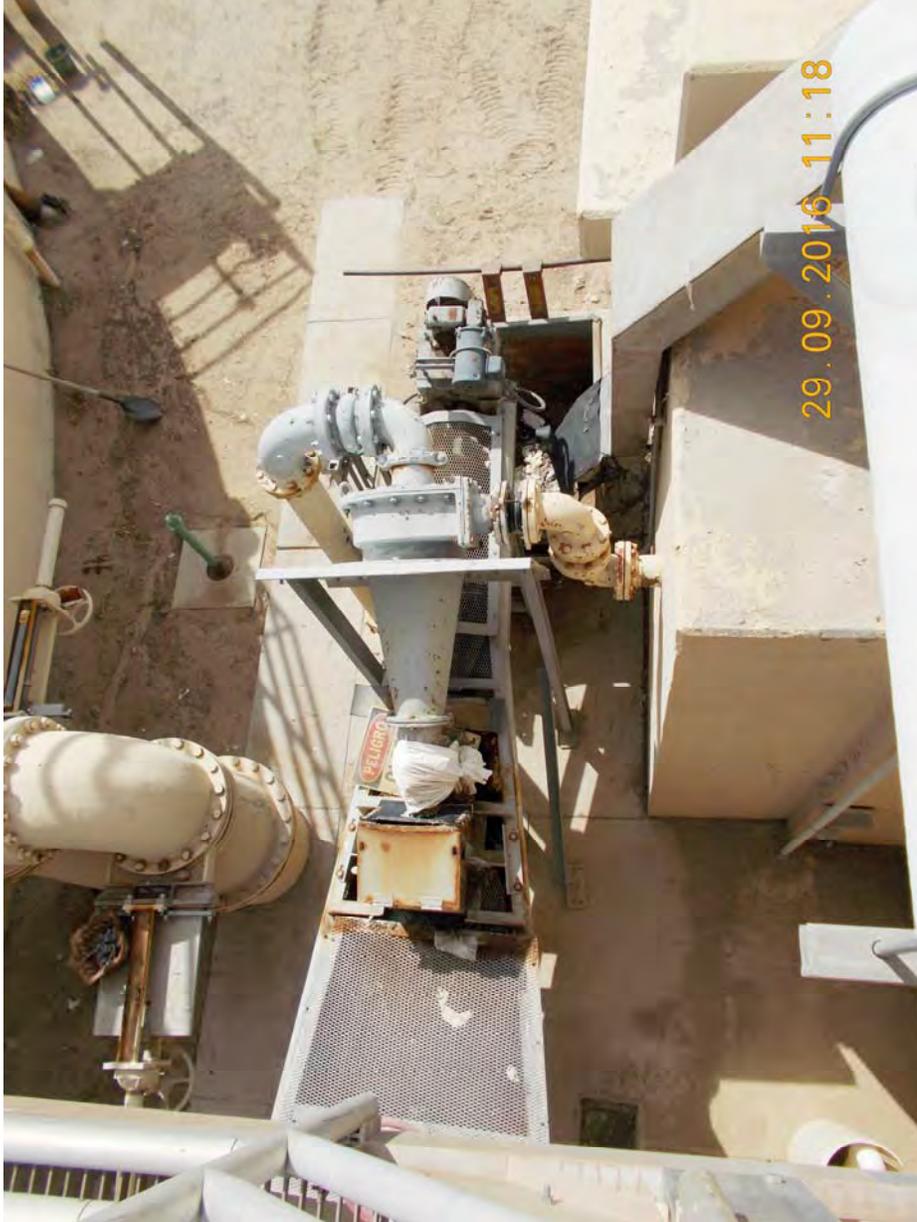
NMED/SWQB
Official Photograph Log
Photo # 3

Subject: Grit Hopper area is operational and the area is clear of trash and debris. This is an improvement.

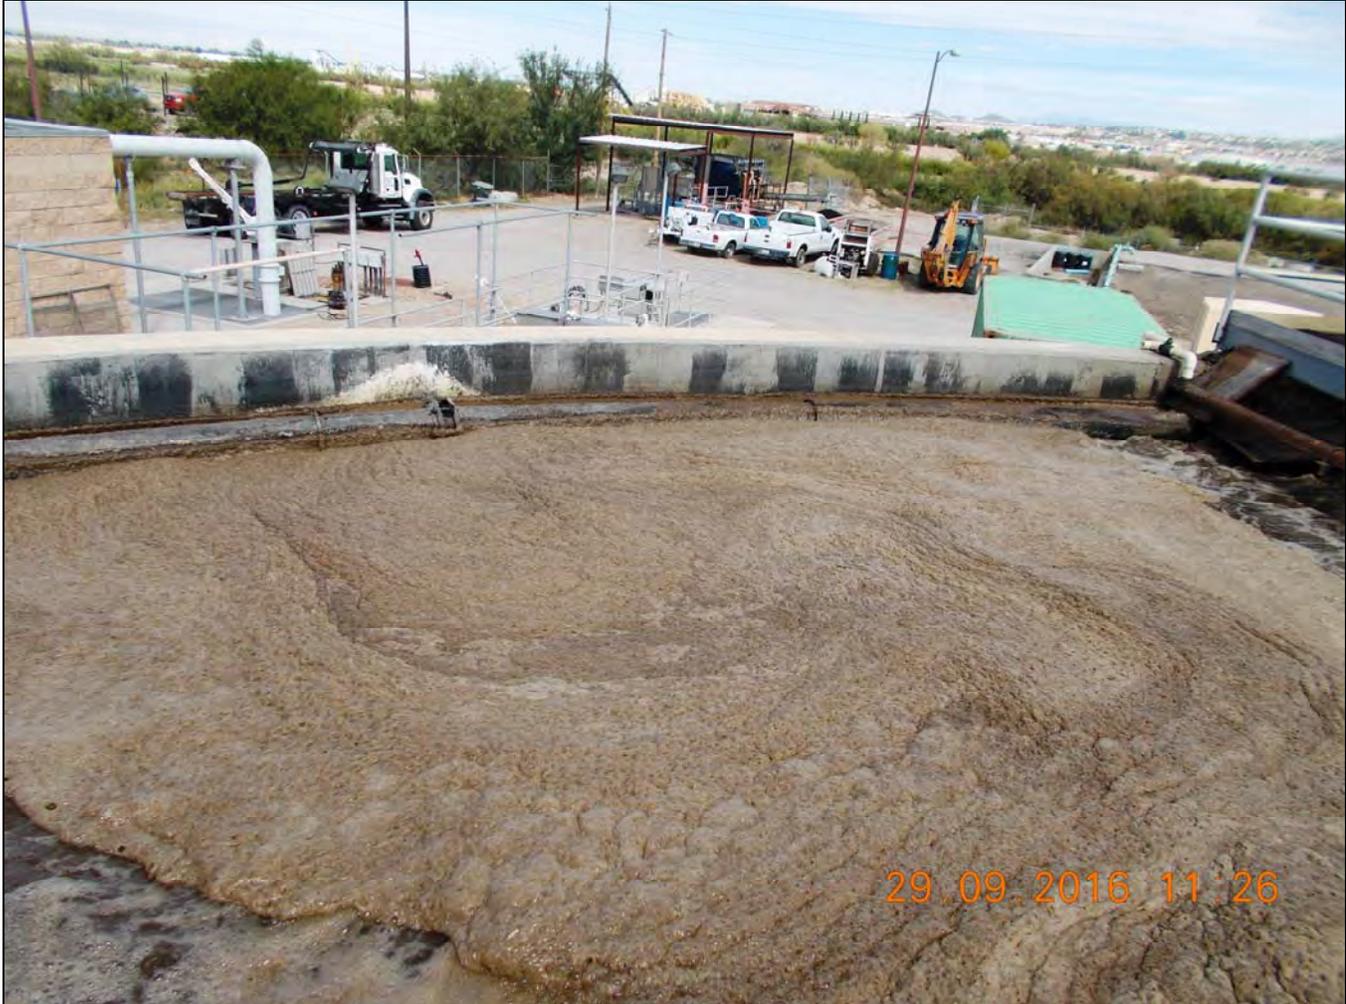
NMED/SWQB
Official Photograph Log
Photo # 4

Subject: The Aeration Basins continue to have a lot of foam, though the reduction in solids content has improved operations overall.

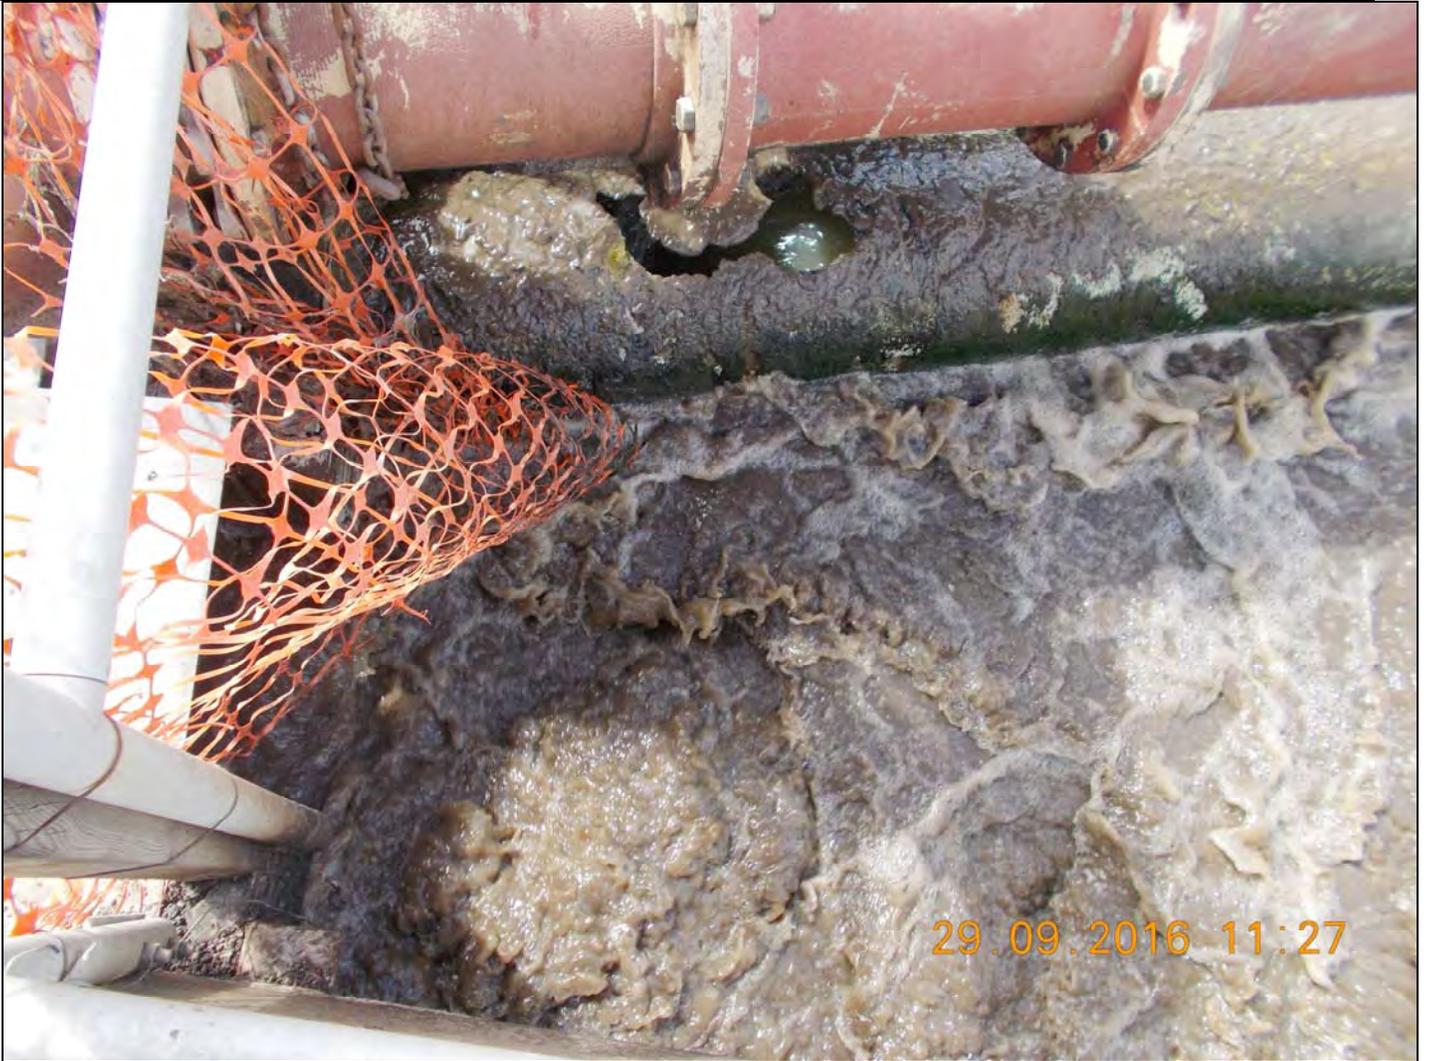
NMED/SWQB
Official Photograph Log
Photo # 5

8. The metal piping in the aeration basins for both the delivery of air from the blowers and the lines for the wastewater have holes and are damaged from the caustic fumes and nature of the wastewater. Some lines should be replaced.

Subject: Worn pipes with hole in the distribution lines and in the aeration lines are found through the plant. The caustic nature of sewage has deteriorated plumbing and replacement lines are necessary.

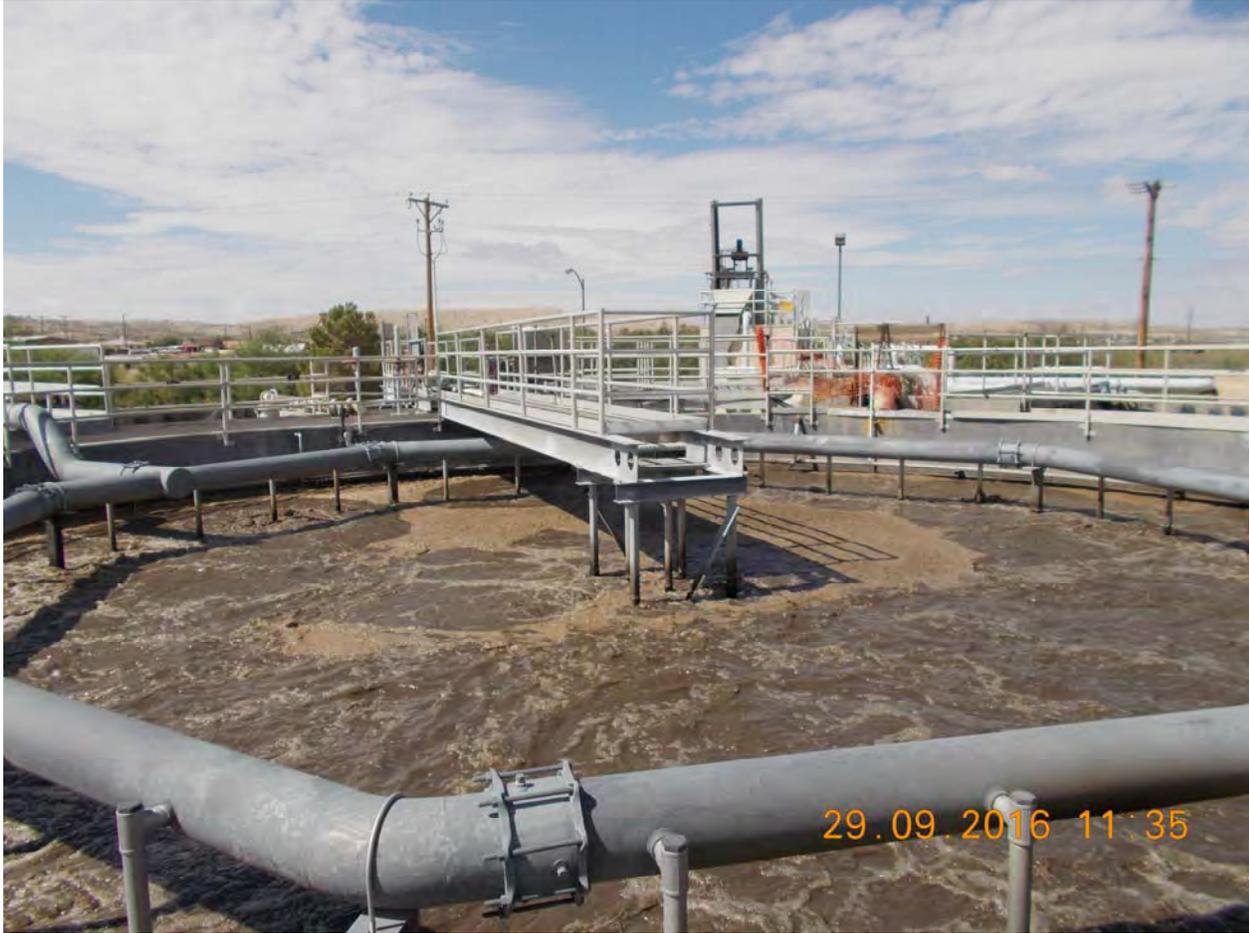
NMED/SWQB
Official Photograph Log
Photo # 6

Subject: The aeration basins are in series and the center basin is the final aeration basin before the wastewater is sent to the secondary clarifiers. This basin had less foam than those earlier in the treatment train.

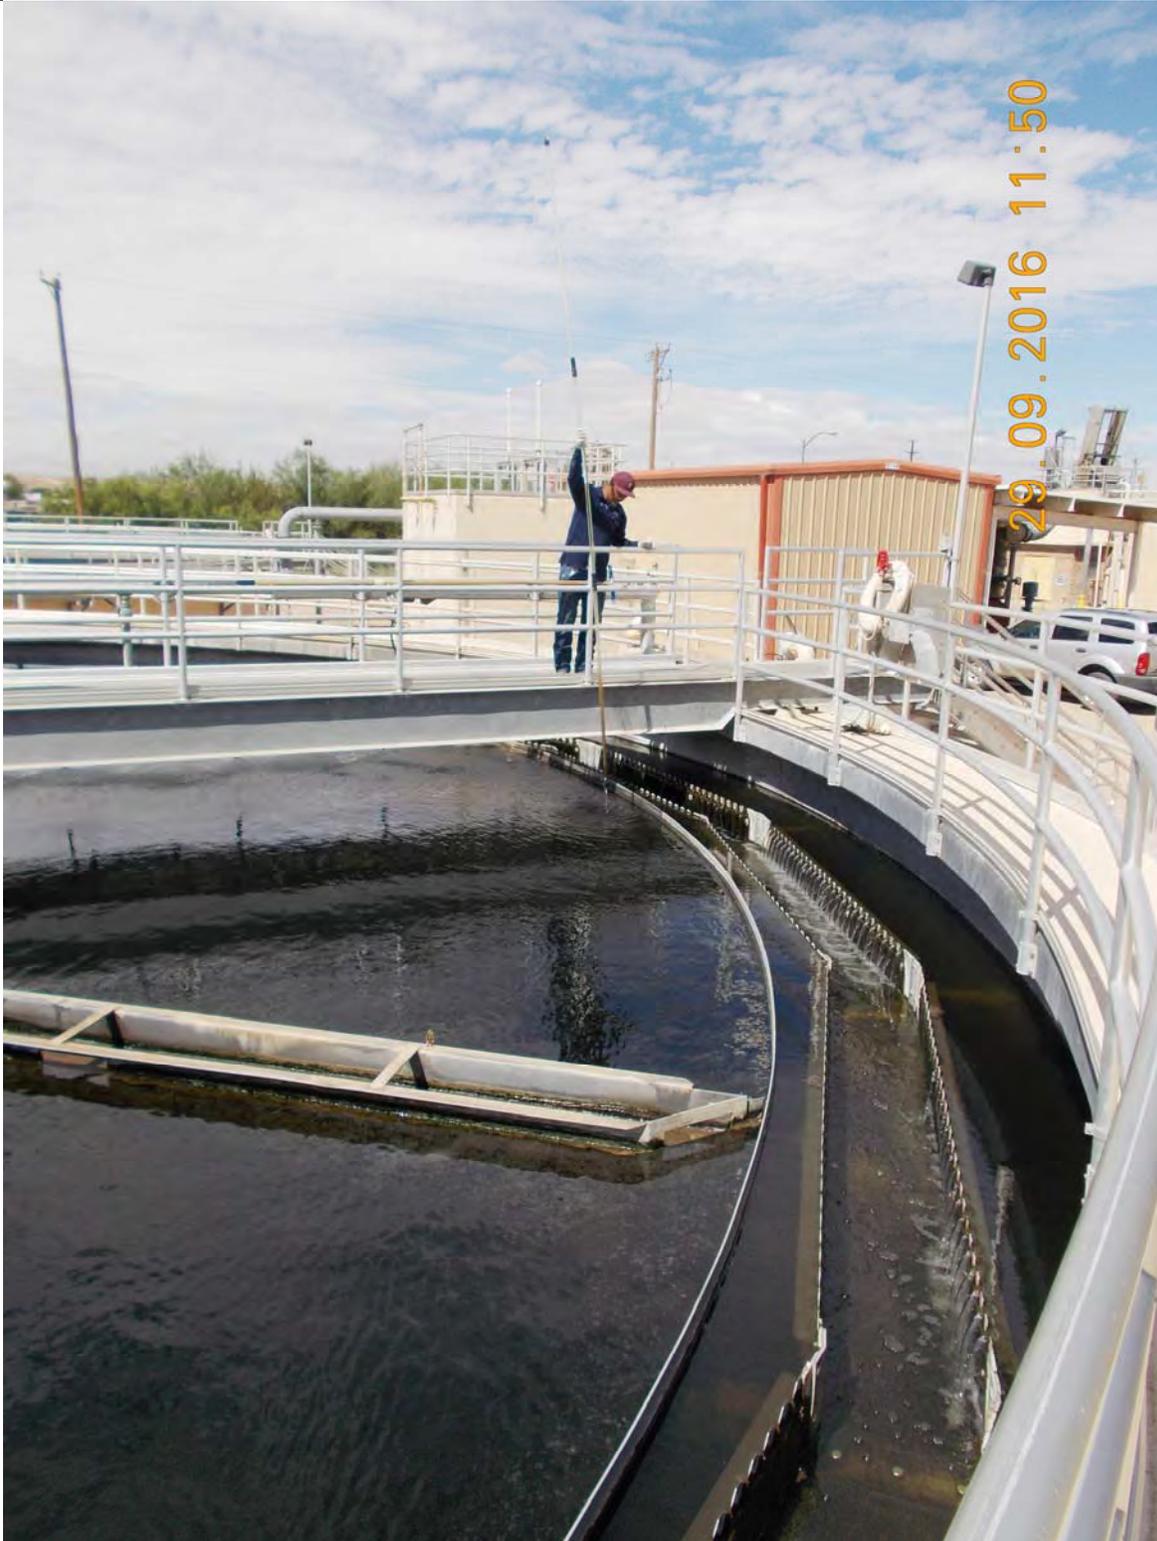
NMED/SWQB
Official Photograph Log
Photo # 7

Subject: Secondary Clarifiers have some uneven flow over the weirs though no solids were observed going over the weirs. The sludge blanket was 2 – 3 feet, tight and the water above was clear.

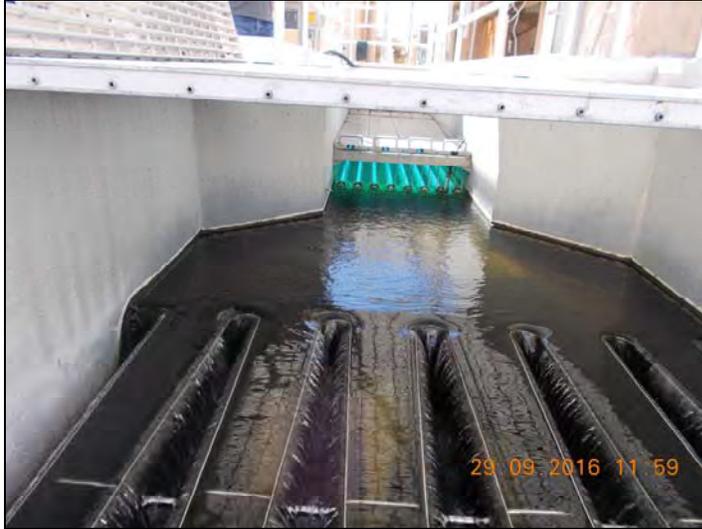
MED/SWQB
Official Photograph Log
Photo # 8

7. Failure of the UV disinfection system resulted in effluent exceedences for E. coli bacter in August 2016. Operators reported the problem to NMED and also made repairs to the system.

Subject: Ultraviolet Disinfection and effluent. The light banks were working at the time of the inspection. The effluent was clear as it flowed out of the facility.

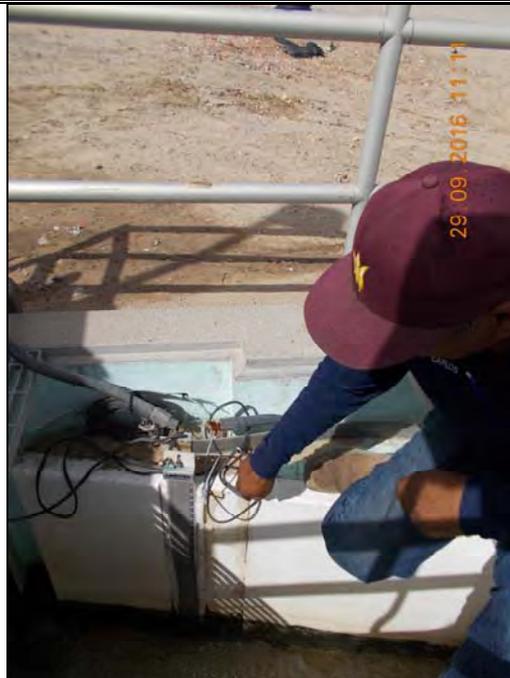
NMED/SWQB
Official Photograph Log
Photo # 9

1The staff gauge is loosely attached to the wall and is buckled so that is warped and may not accurately measure the flow at the high volumes. This staff gauge should be replaced.

Subject: Effluent Staff Gauge at the Parshall Flume is buckling and needs to be replaced.

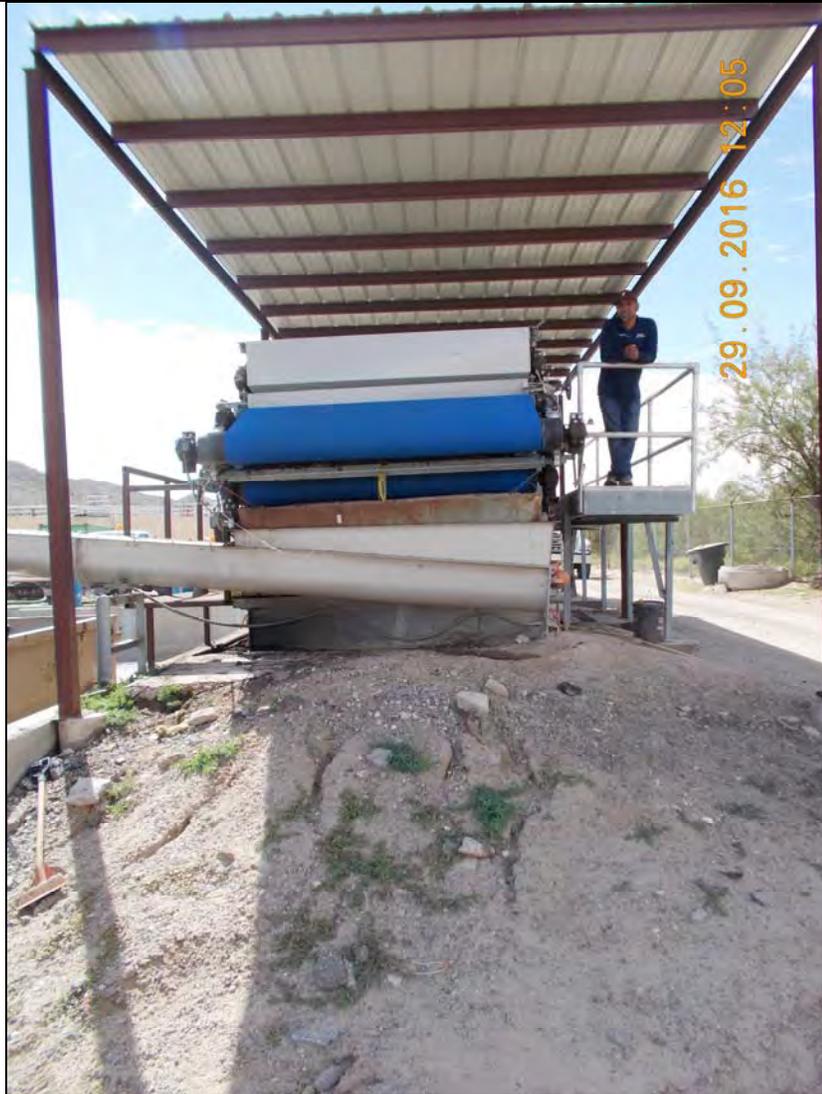
NMED/SWQB
Official Photograph Log
Photo # 10

Subject: The Sludge belt press is operational and run daily.

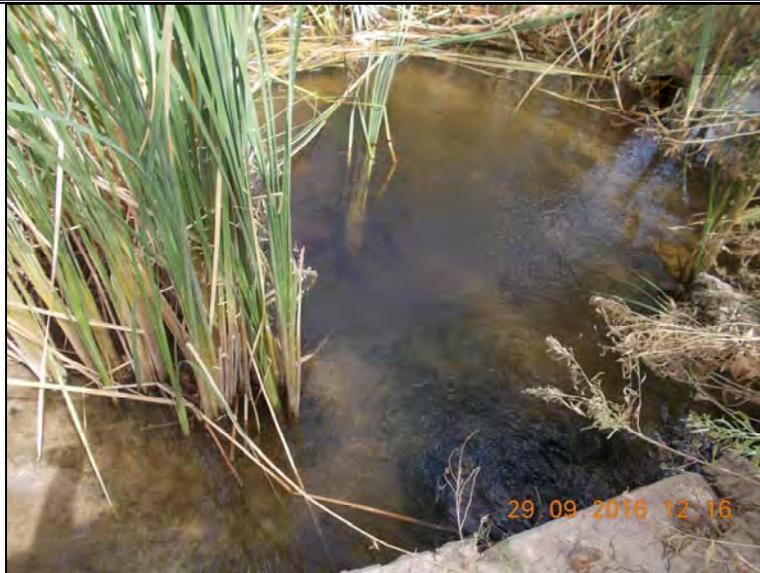
NMED/SWQB
Official Photograph Log
Photo # 11

Subject: The effluent at the Rio Grande was clear and no floating solids were present.

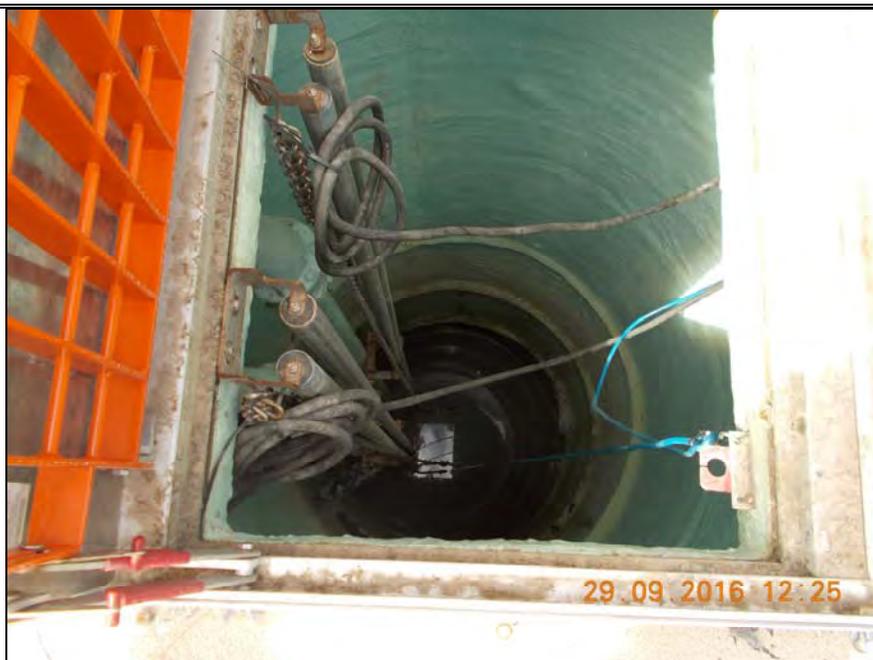
NMED/SWQB
Official Photograph Log
Photo # 12

2. Sanitary Sewer Overflows & Collection system, the permittee is making upgrades and doing maintenance on lift stations that have long been neglected. The Racetrack lift station inner walls have been sealed and coated with a protective membrane (Raven Epoxy), pumps are being maintained and the area has been cleaned.

Subject: Race track lift station, rehabilitation and repairs – coating with an epoxy membrane for protection.

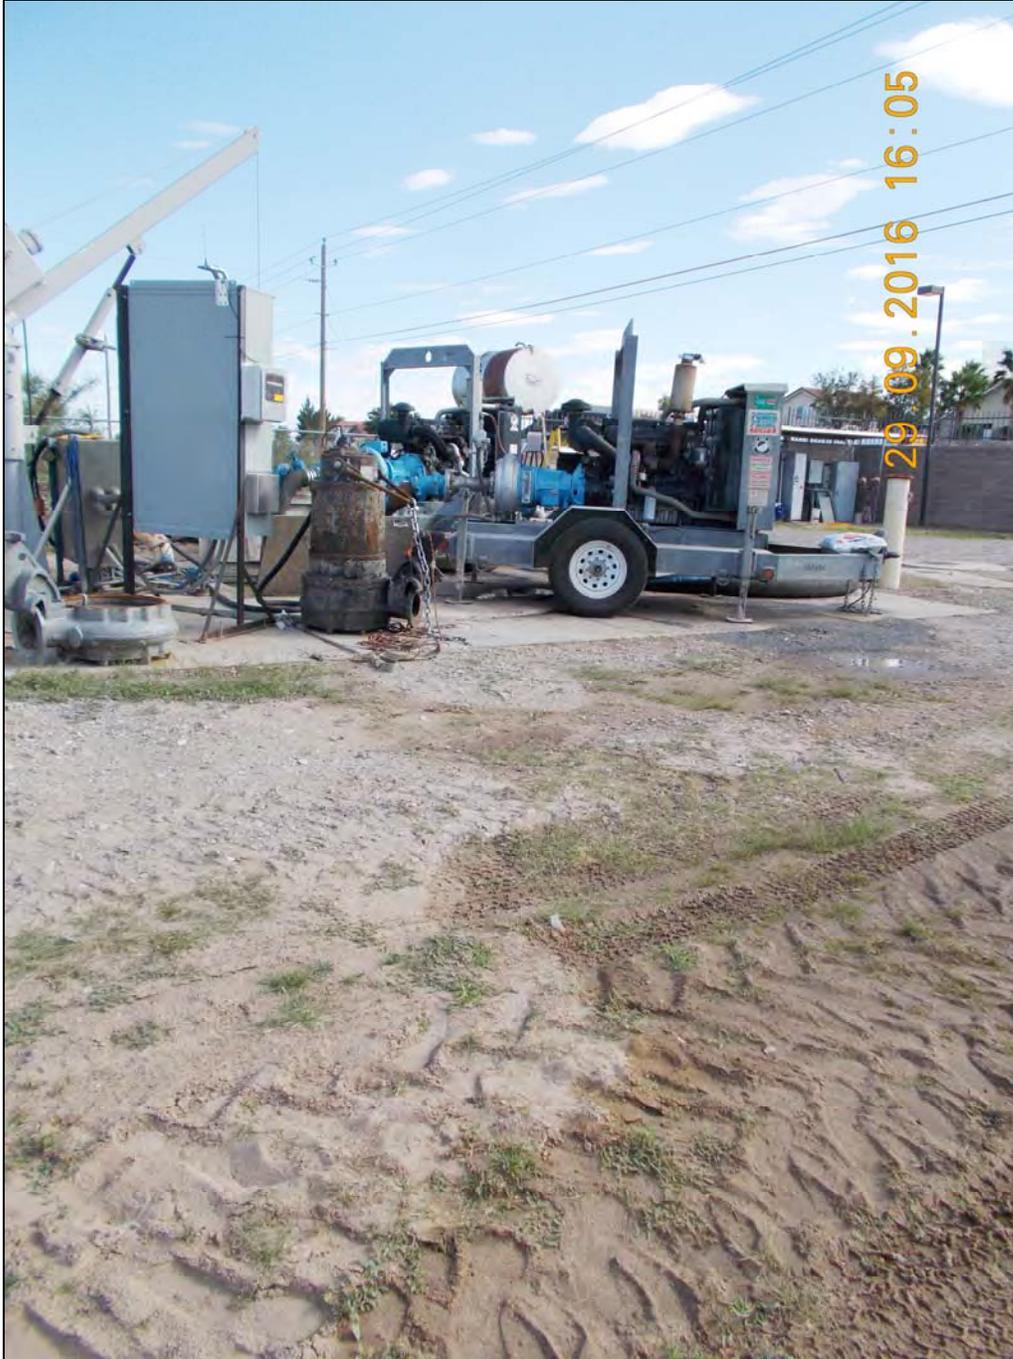
NMED/SWQB
Official Photograph Log
Photo # 13

4. The View Point Lift station at Santa Teresa is still being operated with portable pumps. There was evidence of spillage, oil and debris on the ground. During previous inspections facility representatives stated the portable pumps were temporary. This inspector has observed these pumps onsite for 4 years.

Subject: View Point lift station - Oil and sewage is pooling on the ground.

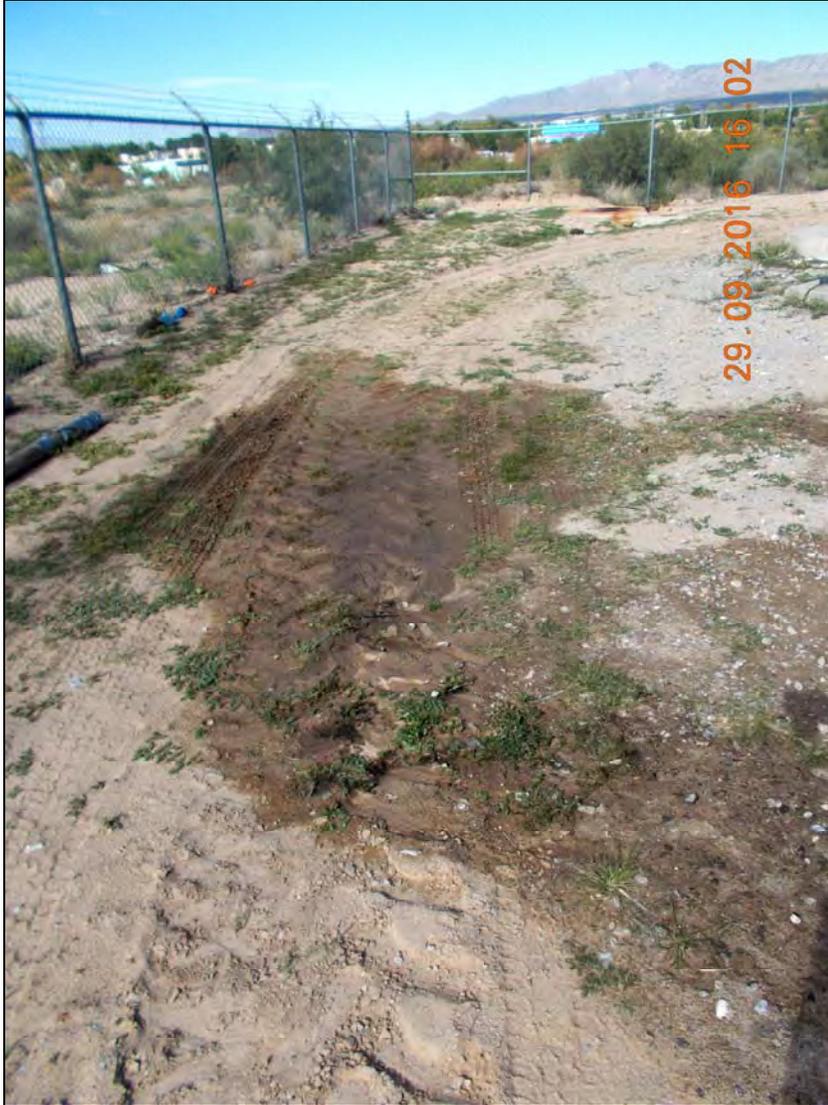
NMED/SWQB
Official Photograph Log
Photo # 14

Subject: Another perspective of the View Point lift station - Oil and sewage is pooling on the ground.
